## Important information concerning forestay fitting 517-914 (2004 – 2008)

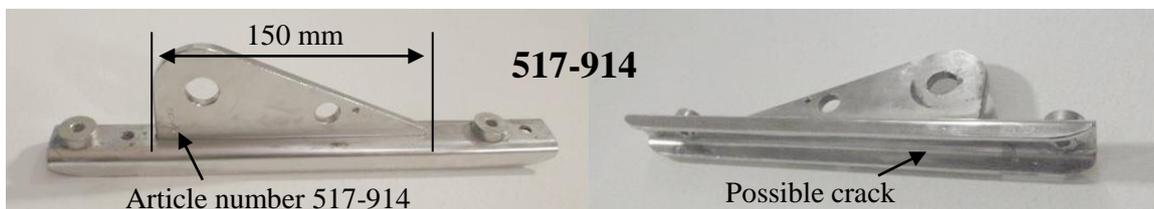
It has been brought to our attention that a few forestay fittings of this design have failed due to a crack in the welding. The crack develops along the weld on the rear side of the fitting inside the mast. It is not visible from the outside. The suspect production batches were used during the period 2004-2008.

All the failed fittings origin from long distance cruising boats with inadequate rig tune and long periods of sailing using only the genoa.

1. Check, before further sailing is done, if your boat is on the list below. If so, please verify that your mast has a forestay fitting marked with the article number 517-914. The number is stamped in the stainless plate and is easy to check from the outside. If your forestay fitting is marked with 517-914-A you already have the improved version and there is no need for a replacement.

2. If that is the case, please fill out and send the [digital form](#) for contacting Seldén.
3. Seldén will immediately deliver a replacement fitting, art no 517-914-90 and decide when and where the replacement will be carried through – naturally in agreement with the owner of the boat.

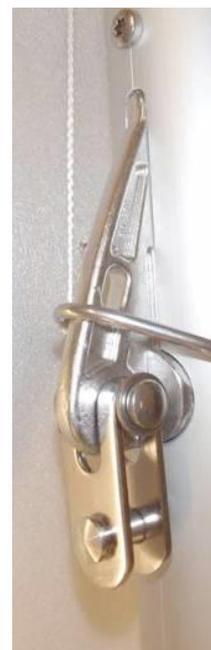
**Forestay fittings marked with article number 517-924, used 2007 and onwards, are not affected by this re call.**
